# Avoidance of Ceramic-Substrate-Based LED Chip Cracking Induced by PCB Bending or Flexing

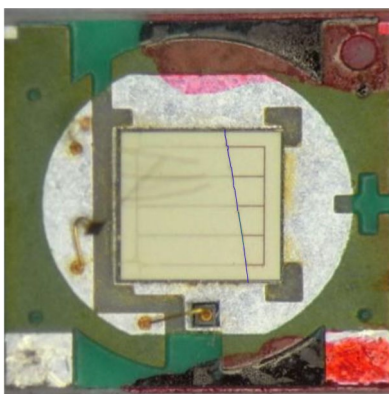
LED chip crack (highlighted in blue) due to PCB bending/flexing

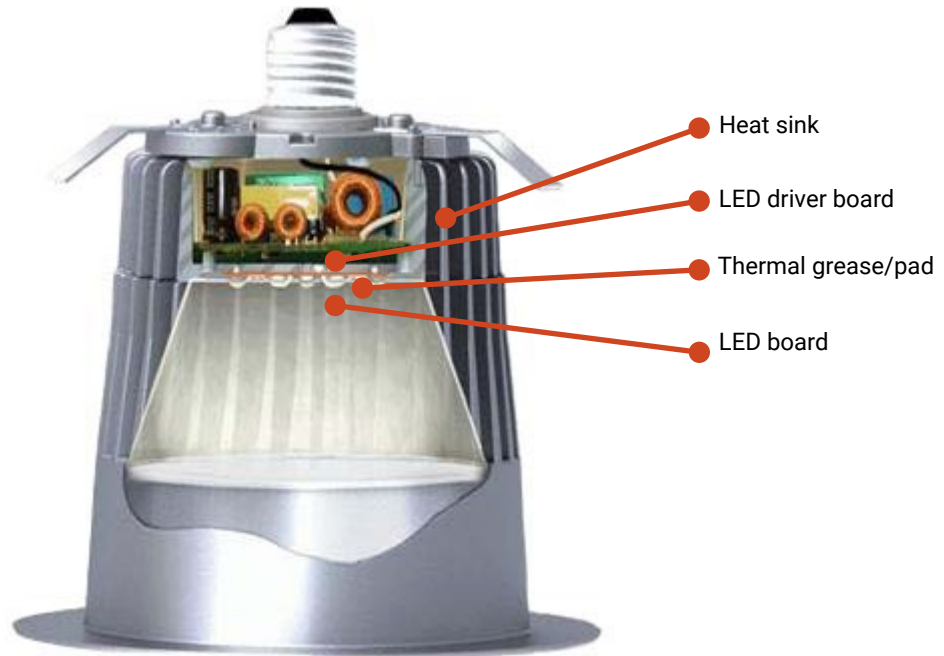
Figure 1: Example LED luminaire

In a typical LED luminaire, the LED board is secured to the aluminum heat sink/housing using one or more metal screws. Thermal grease or a thermal pad is typically applied between the LED board and the aluminum heat sink to help with thermal conduction during luminaire operation. An electronic driver circuit may be included either internal or external to the luminaire depending on the size and design constraints of the luminaire. Figure 1 shows an example of a typical LED luminaire. Figure 2 shows LED boards secured to the underlying heat sink assembly with screws.

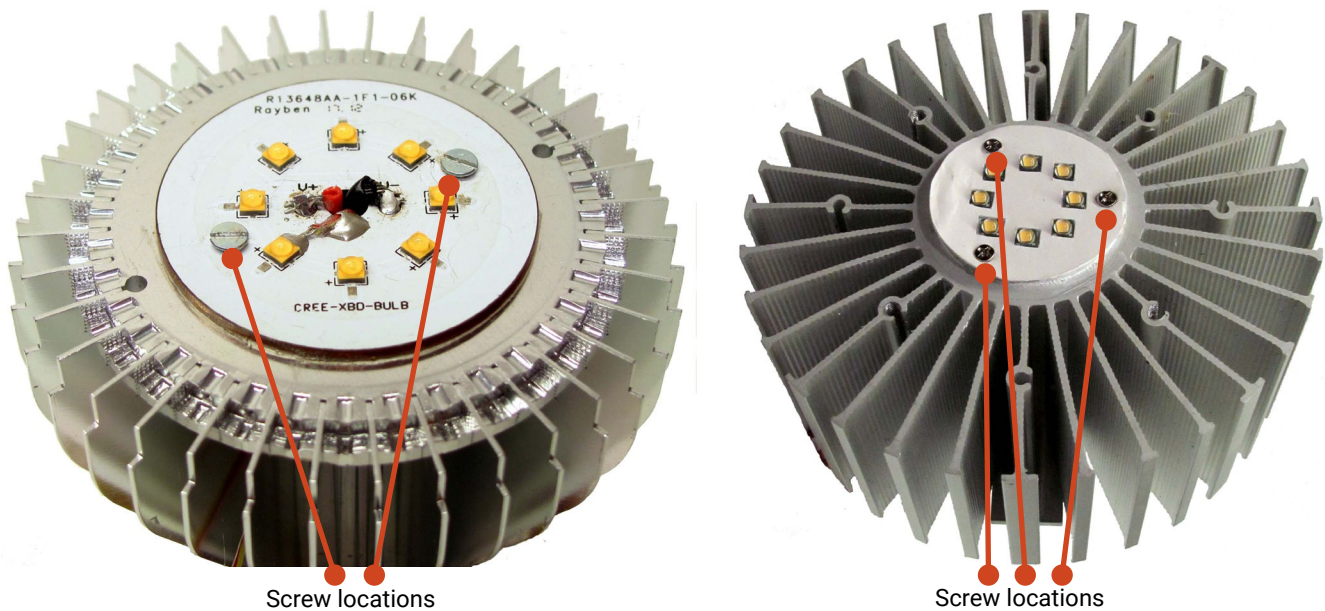
Figure 2: Examples of LED boards attached to a heat sink. Metal screws are typically used in addition to thermal grease/tape to ensure close adhesion to the underlying heat sink assembly.

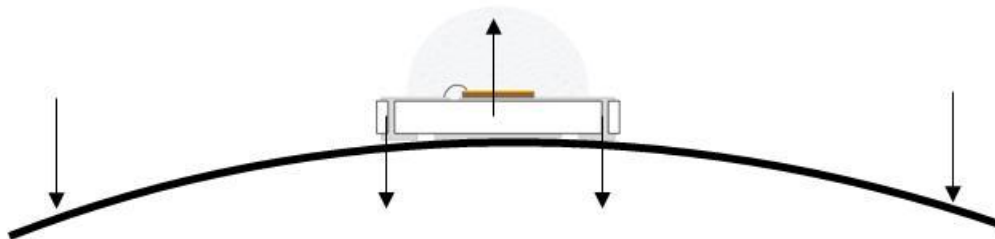
Figure 3: Direction of stress forces applied to LED when PCB is bent/flexed

Manual tightening or automated torquing of metal screws is typically used to attach an LED board to the heat sink assembly during LED luminaire manufacturing. PCB flexing, which occurs due to the board's natural characteristic to form an arc when it is deflected, can easily occur during this process, inducing stress directly on the ceramic-substrate-based LEDs soldered on the PCB. This force is transmitted through the solder to the ceramic substrate and to the eutectically attached LED chip. Figure 3 is a pictorial representation of the directions of stress applied to an LED during PCB bending/flexing.

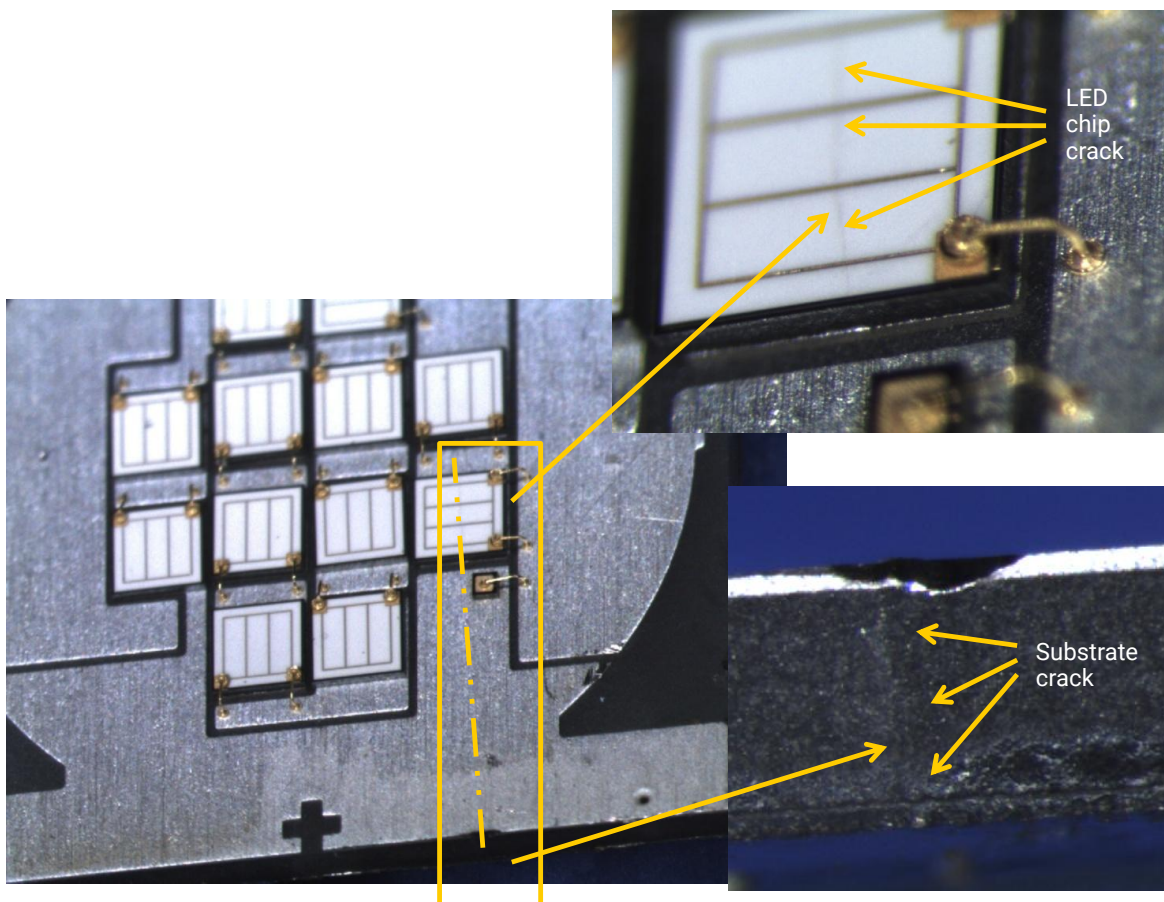
One of the primary failure modes observed in LED chips used in LED luminaires is an LED chip that exhibits leaky and/or shorted LED current/voltage characteristics. Most of the time, a crack in the ceramic substrate onto which the LED chip was soldered can be observed in addition to the LED chip crack. Both cracks are in the same direction and in line, meaning if the crack in the ceramic substrate was extended, it would look as though the crack continues to the LED chip. This is a good indication that the cracks in the LED chips were induced by cracks in the underlying ceramic substrate. Figure 4 shows an example LED exhibiting this trend.

**Figure 4: Crack observed on ceramic-based multichip LED in same direction as ceramic substrate crack**

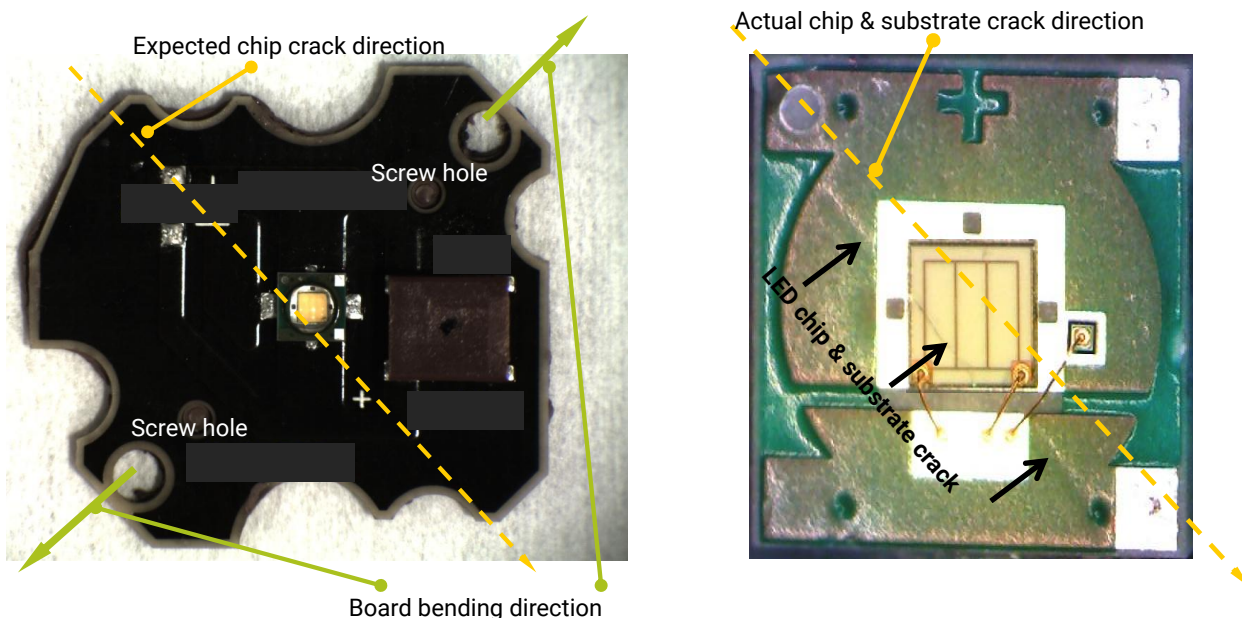
Another trend observed from the LED chip cracks was that, for assemblies that used an even number of screws, the direction of the cracks was always perpendicular to the axis of the screw locations. Figure 5 shows a damaged LED chip that was removed from an LED luminaire. The LED board was attached with two screws.

Figure 5: LED crack perpendicular to the stress direction. Image on the right is a close-up view of the PCB on the left.

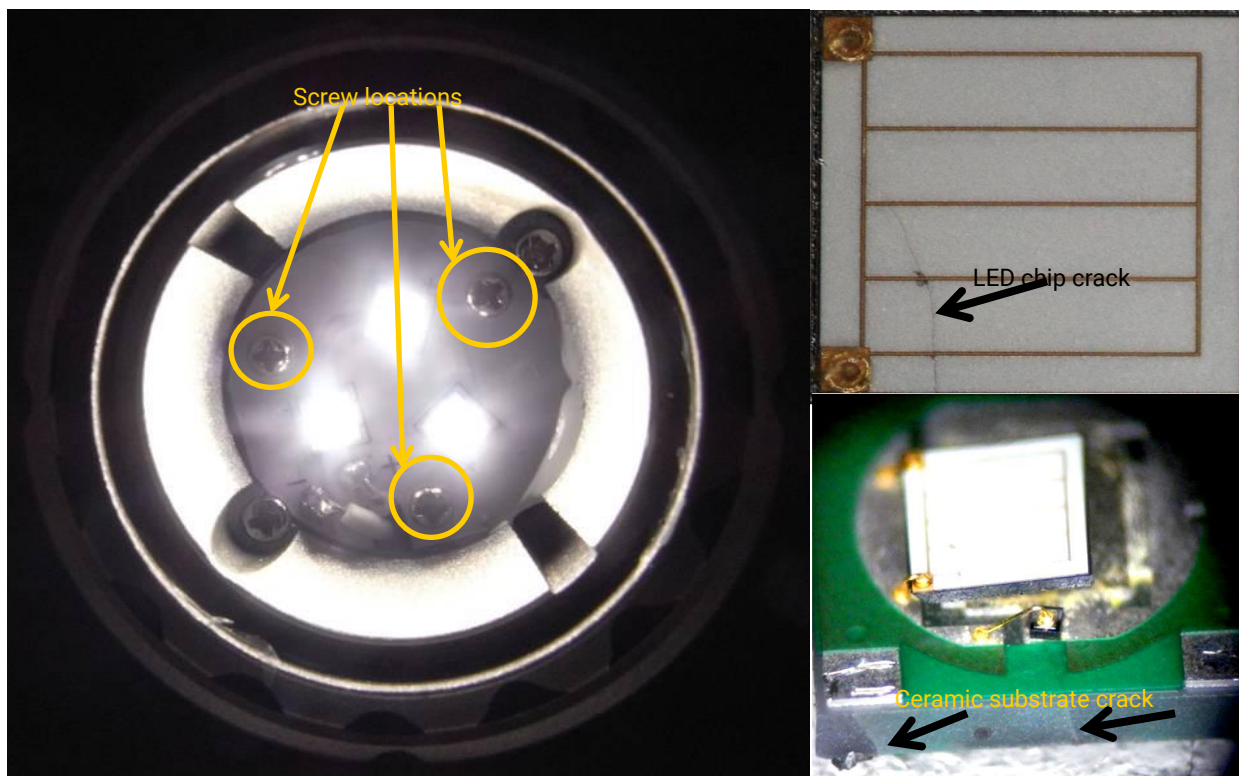
If an odd number of screws was used to attach the PCB, the cracks observed on the LED chip were in the shape of an arc in the direction opposite the board bending direction. Figure 6 shows a damaged LED chip that was on a PCB attached with three screws.

**Figure 6: LED chip crack in an arc shape. Images on the right are close-up views of the LED lamp on the left.**
